Investigating and Resolving Moisture Problems

The renovation of a Florida office building shows repairing and replacing envelope components and mechanical systems improves moisture conditions

By **MIKE WEST, PHD, PE**,
Advantek Consulting Inc.,
Melbourne, Fla.,
and **DAVID HARLOS, SCD**,
Advantek Consulting Inc.,
Gainesville, Fla.

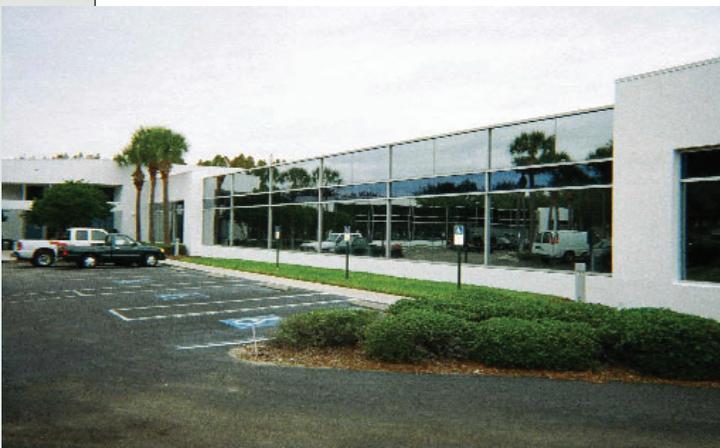
PHOTO A. This Tampa, Fla., building had windows that were unprotected from the area's frequent downpours. The windows were caulked and sealed to fix the problem (Figure 1).

In the Tampa building, pre-construction moisture surveys showed numerous damp areas under windows around the building perimeter. Lawn sprinklers misaimed at walls and landscape levels rising above slab levels played significant roles in persistent wetting. Some damp areas under windows that extended down to floor had visible mold growth behind the windows' vinyl trim. In especially damp areas, mold was visible on the back of gypsum board, with water leaking down the concrete-block knee-walls below the windows. Glass-fiber-batt insulation was visibly wet, and the concrete blocks were wet to the touch. Although leaks were not visible to the eye, radio-frequency (RF) and infrared-(IR-) thermography surveys revealed leaks beneath windows around much of the building perimeter. Sixty-eight moist wall areas of varying size were marked for repair on perimeter walls. While wall construction allowed water in at the top, it also allowed water to exit the building at the bottom, so occupants could not visibly detect serious, persistent water intrusion that could thoroughly wet the wall cavity. Wall depressurization (either wind or HVAC-driven) then could bring mold spores into occupied spaces. Some moist areas were small, while others extended for several feet and caused light-gauge steel framing studs to rust through. Floor dampness in a few areas extended 1 to 2 ft from the walls, indicating a perimeter water source persistent enough to soak into the concrete floors.

- Repair and caulking/sealing of roof parapet caps.
- Replacement of exterior caulking at all windows and wall penetrations (Photo A and Figure 1).
- Elastomeric coating of building exterior.
- Exterior caulking beneath all window frames and undercuts.
- Repeated adjustment of sprinkler-head aim.
- The lowering of the landscape grade below building-slab level, the sloping away of the landscape from the building, and the installation of drains.
- The extension of roof flashing over exterior doors and the installation of wide rain gutters and downspouts over door-top catch basins at the ends of the four building wings.
- The addition of catch pans and drains to direct roof runoff and condensate away from building walls.

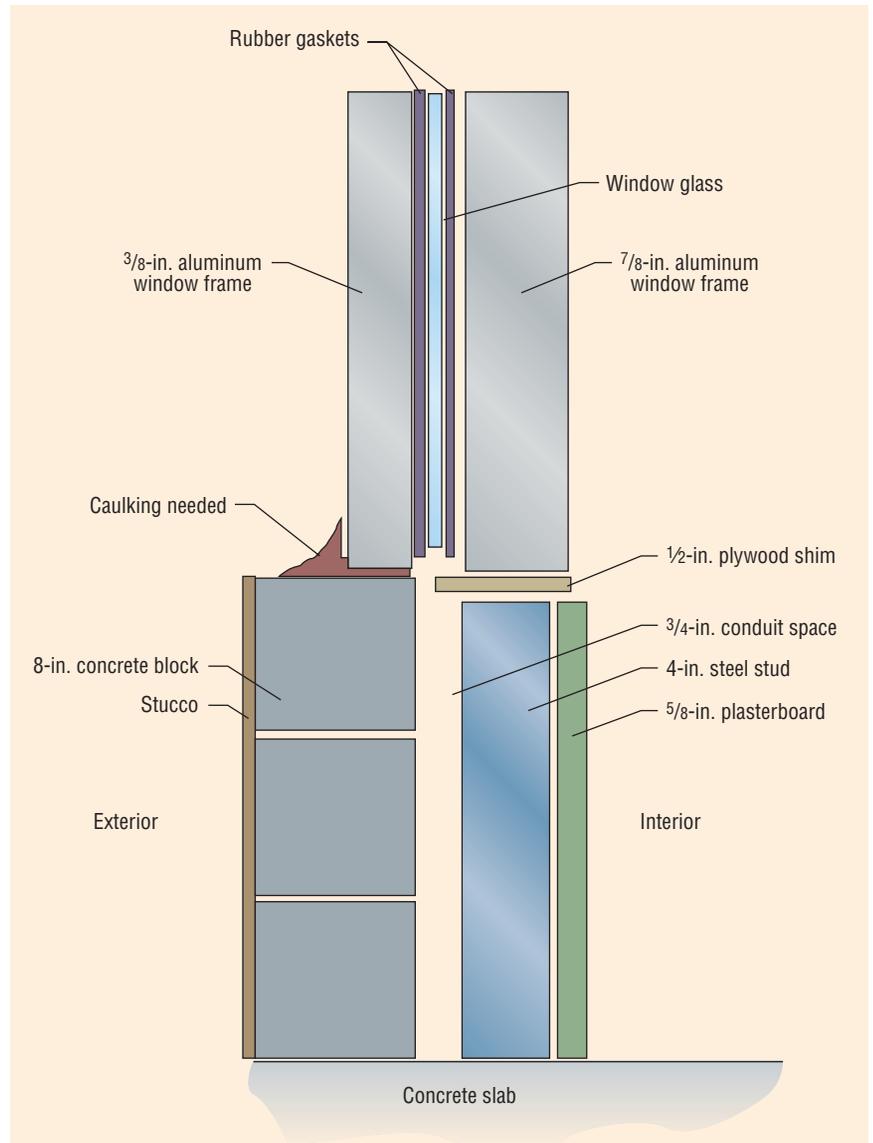
FIGURE 1. Windows were caulked and sealed to stop leakage.

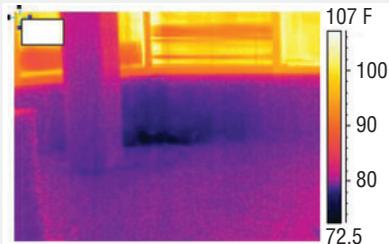
FIGURE 3. Moisture enters a wall and slab at a slab-wall joint because of an elevated landscape-soil level.

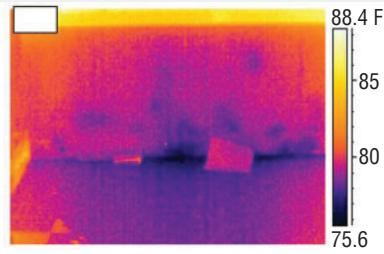
FIGURE 2. Wet fiberglass in a wall cavity caused by water entering a building exterior can produce a mottled pattern in an IR image where unevenly wetted fiberglass contacts gypsum board. Such patterns may be revealed by RF moisture probes, but only after many measurements.

A critical task is to identify and correct all sources of moisture intrusion. In the Tampa building's areas that showed evidence of high moisture levels, interior walls were opened, dried, and replaced with new gypsum board and interior finish. The insulation was replaced with a non-absorbing polyisocyanurate insula-

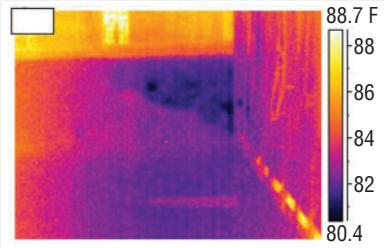
FIGURE 4. Moisture intrusion from above may be revealed by obvious seepage patterns where water enters from failed window caulk above a kneewall.

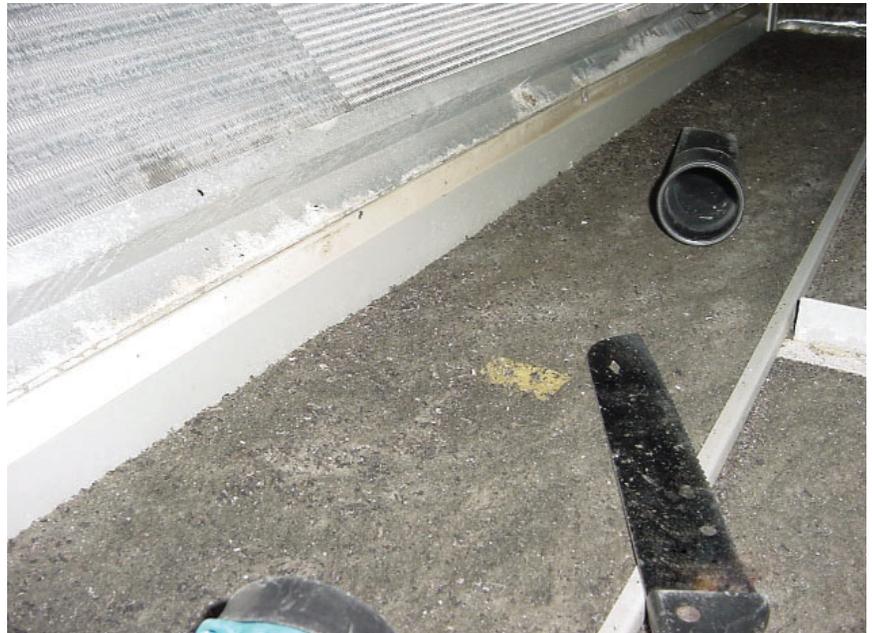
PHOTO B. Granular particulates shed from an air-handler coil.

A coarse-particulate problem developed after the original contractor completed initial coil cleaning. Large amounts of material remained lodged deep in the coil fins after they were cleaned with a foaming agent. After the air-conditioning demand dropped and the coils dried thoroughly, the film of loosened debris contracted, gradually

blew through the coils, and was ejected into the supply ducts. It eventually fell into the occupied space as brittle black flakes and granules. These conspicuous particles were a nuisance and concerned some occupants. This shedding condition is a common outcome of the use of light-duty “no-rinse” coil-cleaning products on heavily soiled cooling coils. No-rinse coil cleaners often are used when an air handler is within a finished space (carpeting, drywall, etc. are installed) or a contractor cannot or does not remove an air-handler coil to the outdoors so it can be rinsed with water thoroughly or cleaned with a pressure washer. After the particulates were discovered,

the offending units were dry cleaned with a high-pressure air jet and high-efficiency-particulate-arrestor (HEPA) vacuumed to reduce particulate shedding (photos B and C).

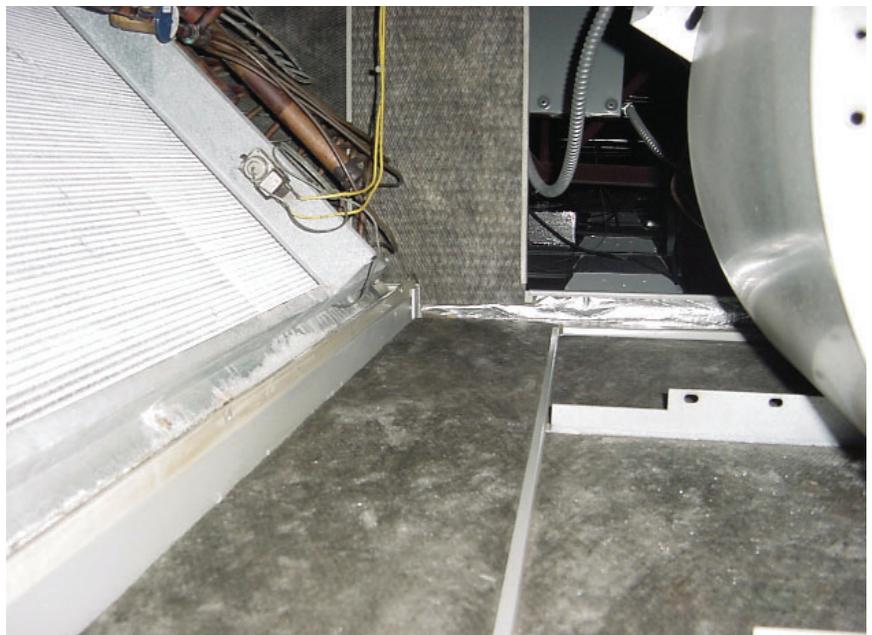
PHOTO C. Air handler disinfected and cleaned with a HEPA vacuum.

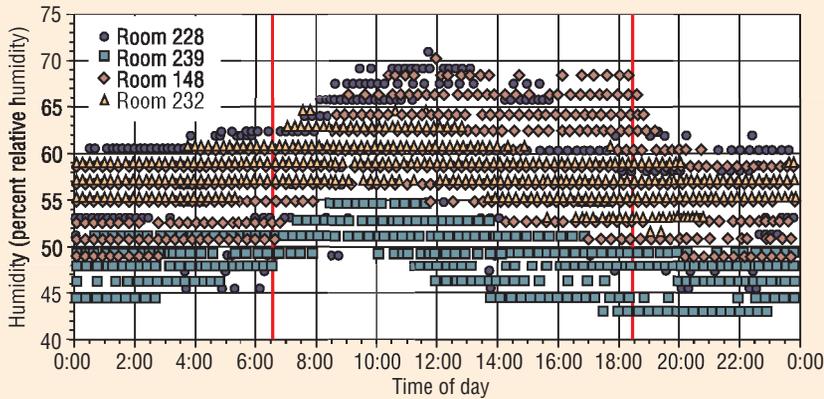
FIGURE 5. Humidity by time of day. This trend data shows humidity and comfort conditions from May 25-31, 2006.

Humidity and comfort conditions were measured shortly after the project was completed (figures 5 and 6). Although humidity sometimes drifted above the desired maximum, conditions remained in the comfort zone 81 percent of the time during the test period. Keeping peak humidity levels at no higher than 70-percent relative humidity and having no less than 80 percent of readings in the comfort zone was defined as minimally acceptable by the building owner.

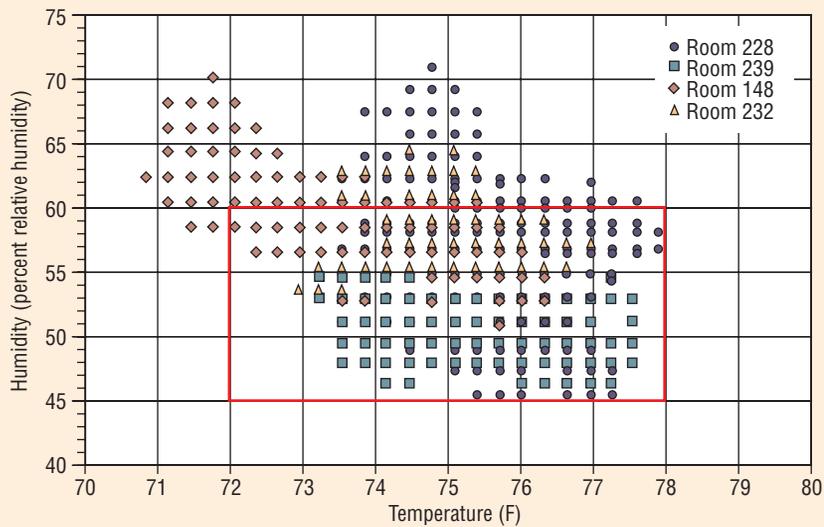
FIGURE 6. This trend data shows space conditions from May 25-31, 2006.
